# Manhole Inspection Summary

Manhole # S27CC\_011MH

**Location** Address: **REAR OF 611 LAFAYETTE AVE** Cross Street: **PENNSYLVANIA AVE**

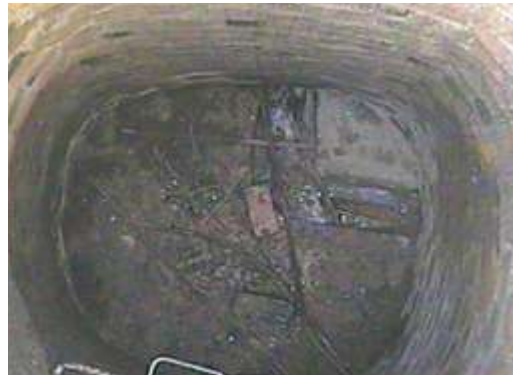
Top View

**Bench** ☒ Exists Material: **Brick** ☐ Parged  
Condition: ☐ Sound ☐ Cracked ☐ Root Intrusion ☐ Deteriorated ☐ Leaks ☒ **Debris**

DEBRIS

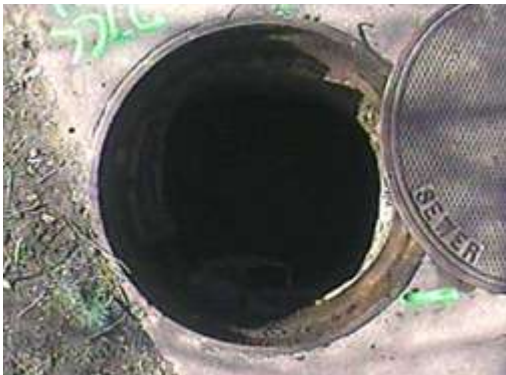
Top View

**Frame** Offset: **3** (in.) Condition: ☒ Sound ☐ Cracked ☐ Leaks

FRAME OFFSET

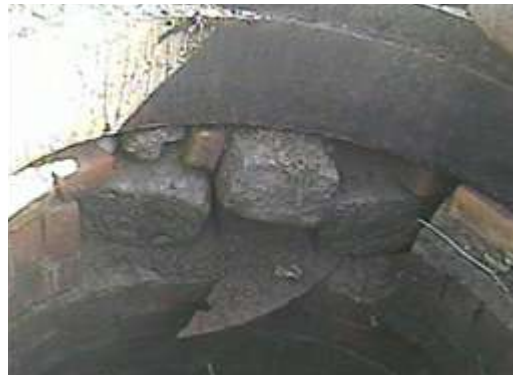
Defect 1

Comments **CHIMNEY DETERIOTED EXCESSIVELY - SEE PHOTO**

**Chimney / Frame Adjustment** ☒ Exists Material: **Brick and Stone** ☐ Parged Height: **11** (in.)  
Condition: ☐ Sound ☒ **Cracked** ☐ Root Intrusion ☒ **Loose Brick** ☒ **Deteriorated**  
Infiltration: ☒ None ☐ Joint ☐ Cracks ☐ Mortar ☐ Roots ☐ Wall

CHIMNEY DETERIORATED/LOOSE BRICKS/CRACKS

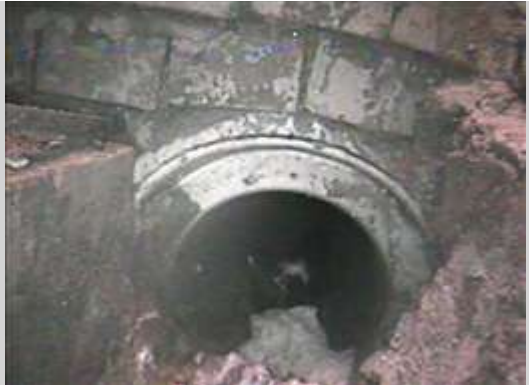
12 O'Clock Outflow

8 in. Circular Gravity Sewer  
Pipe Out @ 12 O'Clock

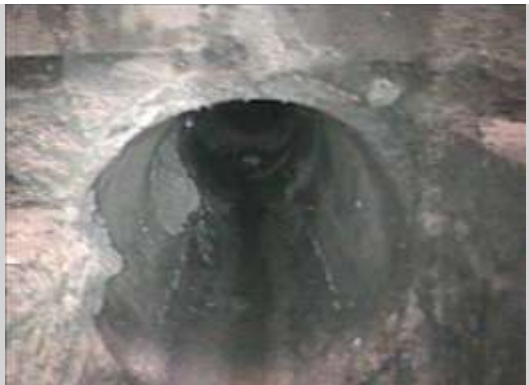
3 O'Clock Inflow

8 in. Circular Gravity Sewer  
Pipe In @ 3 O'Clock
